Harness Structural test Report - EN

Inspection certificate number: PH_429.2024

Name: **SKY ZEN**
 Type: **ABS**
 Size: **M**
 Serial number: **20**
 Impact pad type: ⁽¹⁾ **n/a**
 Clip-in weight [kg]: **100**
 Date of test: **17.01.2024**

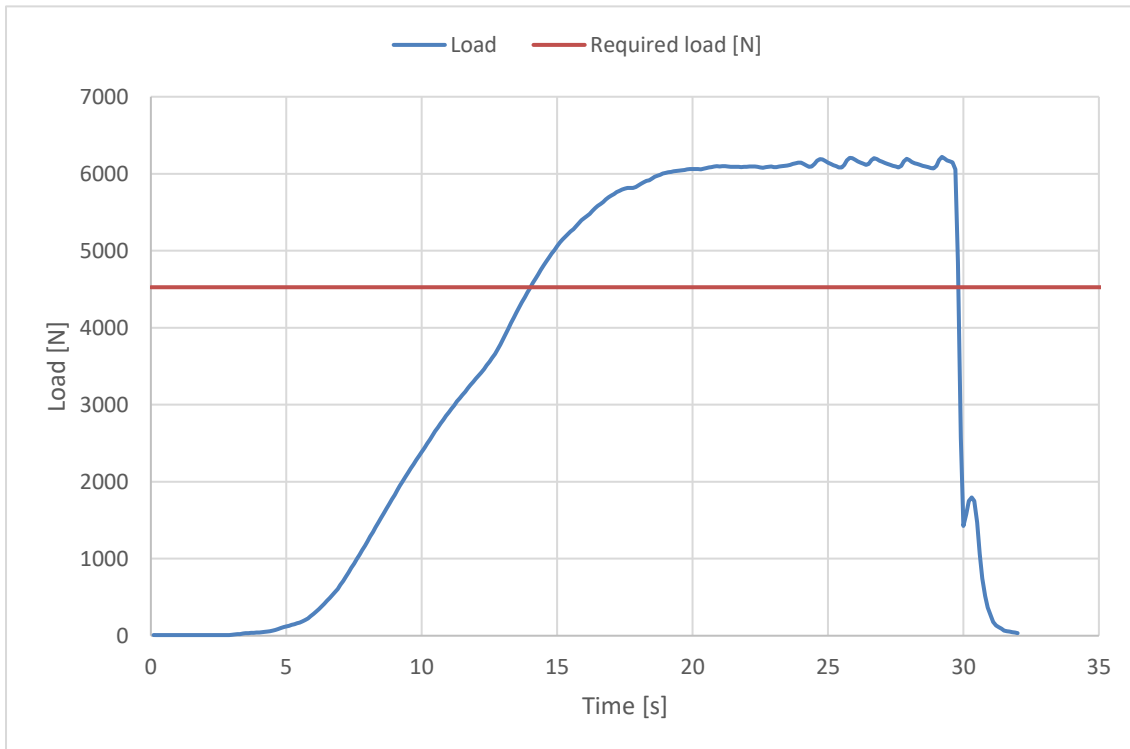
Test ID 01

Test duration [s] **15.8**
 Any signs of structural failure **No**
 Slippery test OK **Yes**
 Test results **POSITIVE**

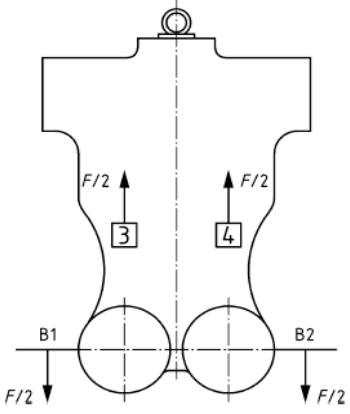
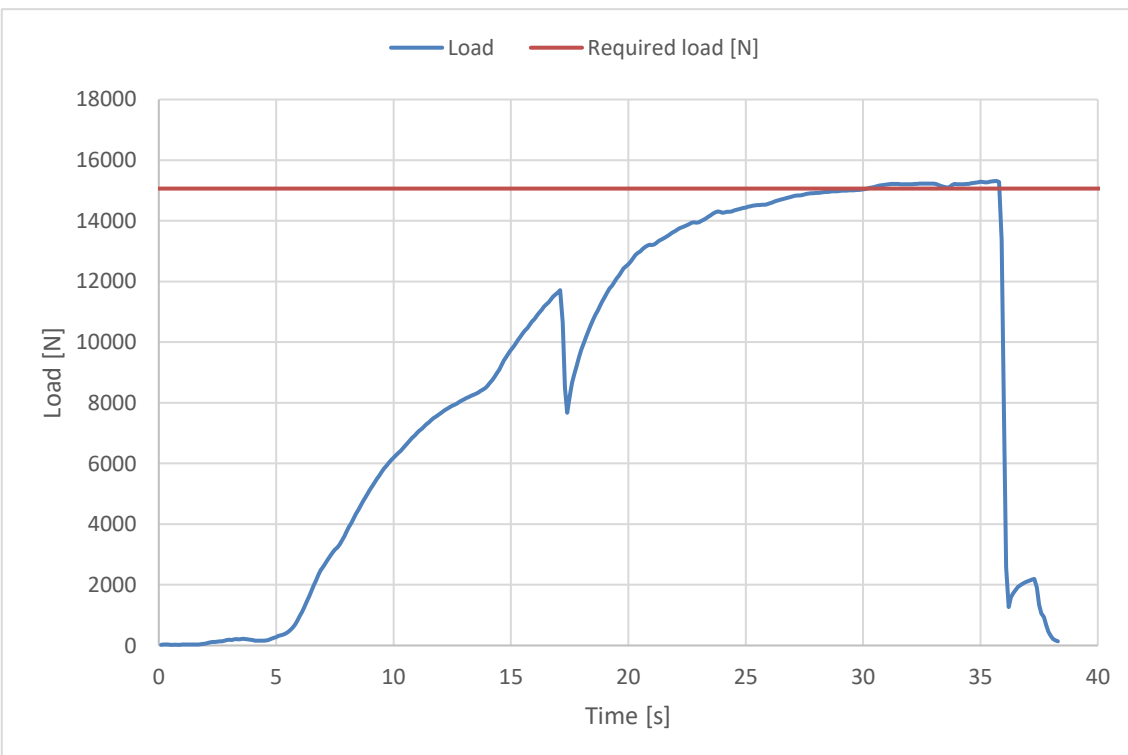
Test ID 03

Reference in standard	5.5.1.1b	
Test setup	Positive symmetric load	
Attachment points	Both main riser attachment (3,4)	
Anchor points	Dummy (B1, B2)	
Required load [g]	15	
Required load [N]	15000	
Minimum test duration [s]	5	
Result		
Test duration [s]	5.7	
Any signs of structural failure	No	
Slippery test OK	Yes	
Test results	POSITIVE

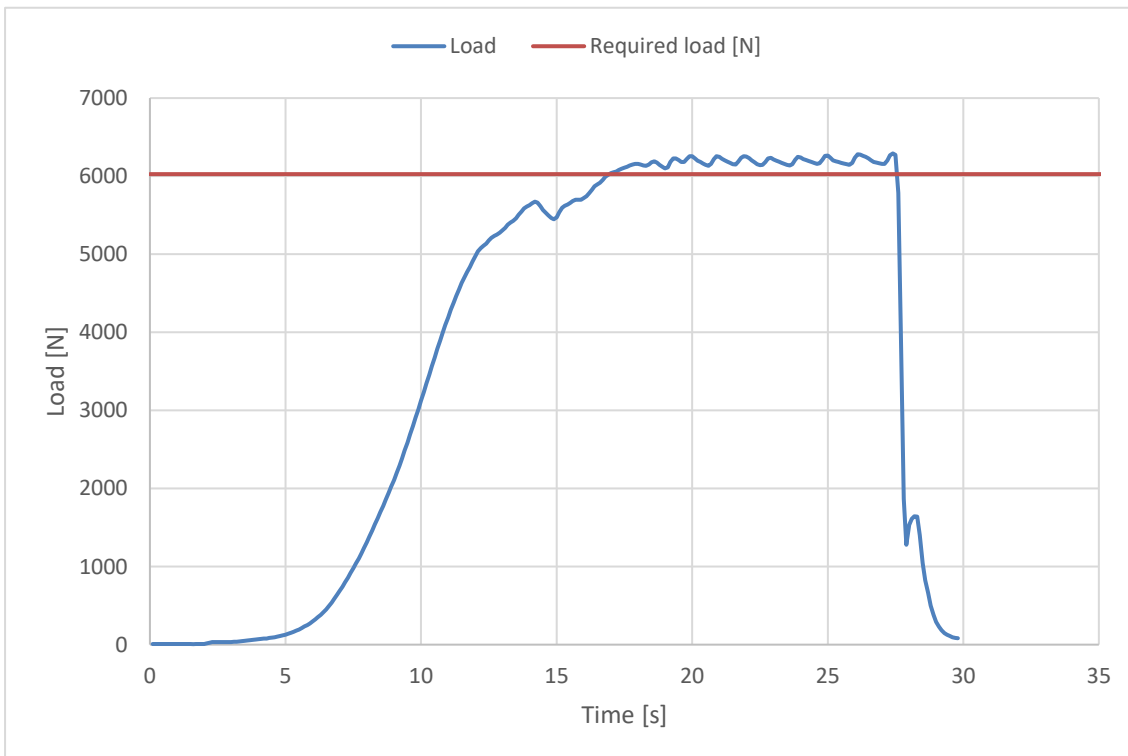
Test ID 05

Standard	EN 1651
Reference in standard	5.5.1.2
Test setup	Positive asymmetric load
Attachment points	One riser attachment (3 or 4)
Anchor points	Dummy (C)
Required load [g]	6
Required load [N]	6000
Minimum test duration [s]	5
Result	
Test duration [s]	10.6
Any signs of structural failure	No
Test results	POSITIVE

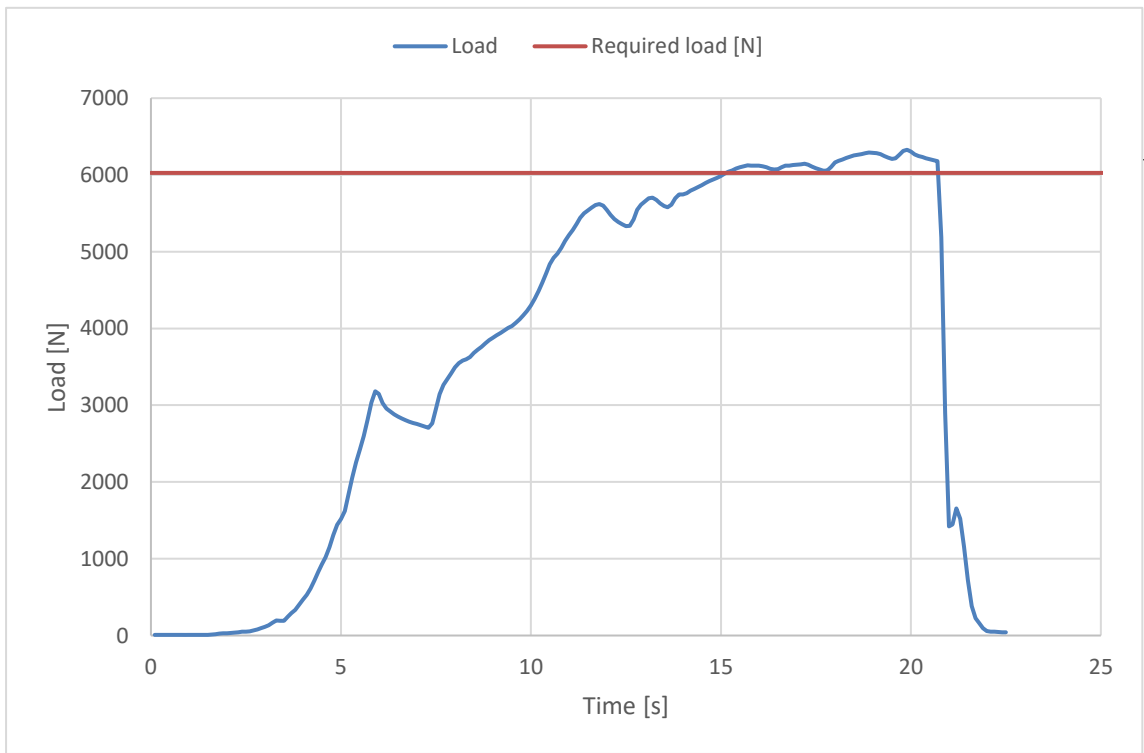
Test ID 06

Standard	EN 1651
Reference in standard	5.5.1.6
Test setup	Negative symmetric load
Attachment points	Both main riser attachment (3,4)
Anchor points	Dummy (A)
Required load [g]	6
Required load [N]	6000
Minimum test duration [s]	5
Result	
Test duration [s]	5.6
Any signs of structural failure	No
Test results	POSITIVE

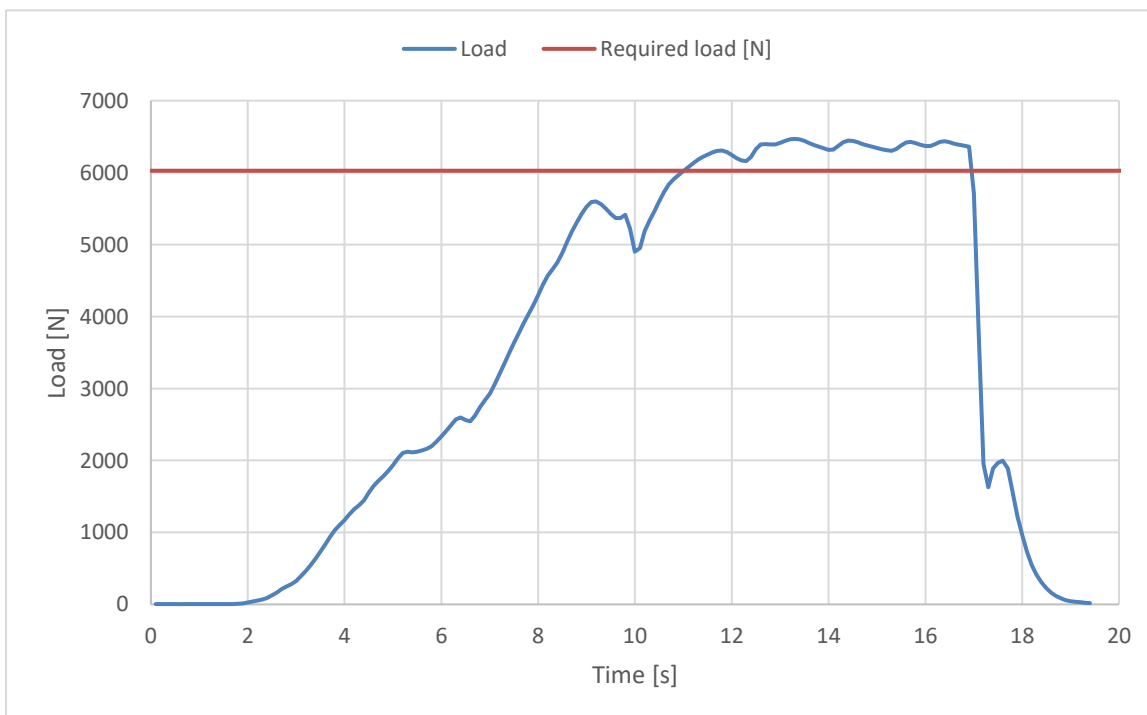
Test ID 12

Standard	EN 1651
Reference in standard	5.5.1.7
Test setup	Upright (landing) position load
Attachment points	Both main riser attachment (3, 4)
Anchor points	Both legstrap of harness (no dummy)
Required load [g]	6
Required load [N]	6000
Minimum test duration [s]	5
Harness type	type c
Result	
Test duration [s]	5.9
Any signs of structural failure	No
Slippery test OK	Yes
Test results	POSITIVE
